North American Society for Trenchless Technology (NASTT)
NASTT's 2016 No-Dig Show

Paper: MA-T1-03

**Injection Grouts and CIPP Lining Revitalize Buried Assets on
Treasure Island**

Michael Helfrich, City of Treasure Island, Treasure Island, FL, USA

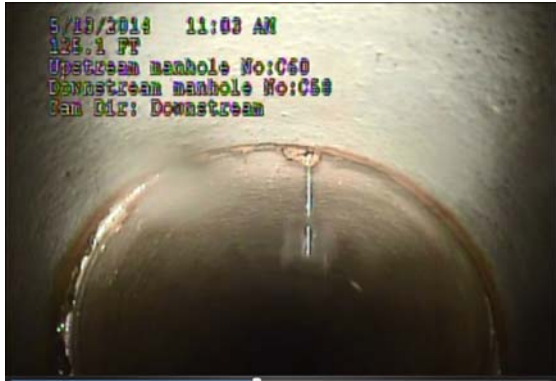
Figure 5. Gravity Sewer Line with Constant Drip from Infiltration

The condition of the clay (Terracotta) pipe was cracked, allowing a large amount of groundwater to infiltrate as illustrated in Figures 5 and 6. The result of the video surveillance allowed us to identify the two areas shown in Figure 7 as the main culprits of infiltration.

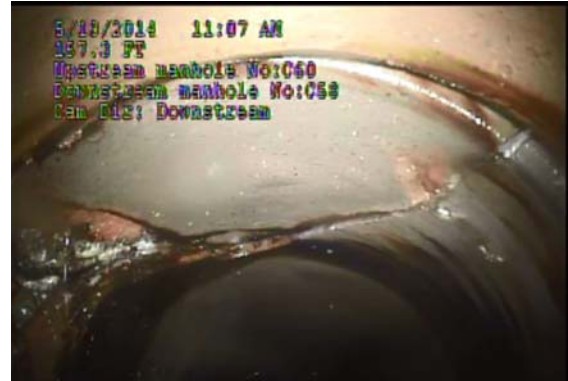
Figure 6. Typical Gravity Sewer Line Damage with Infiltration

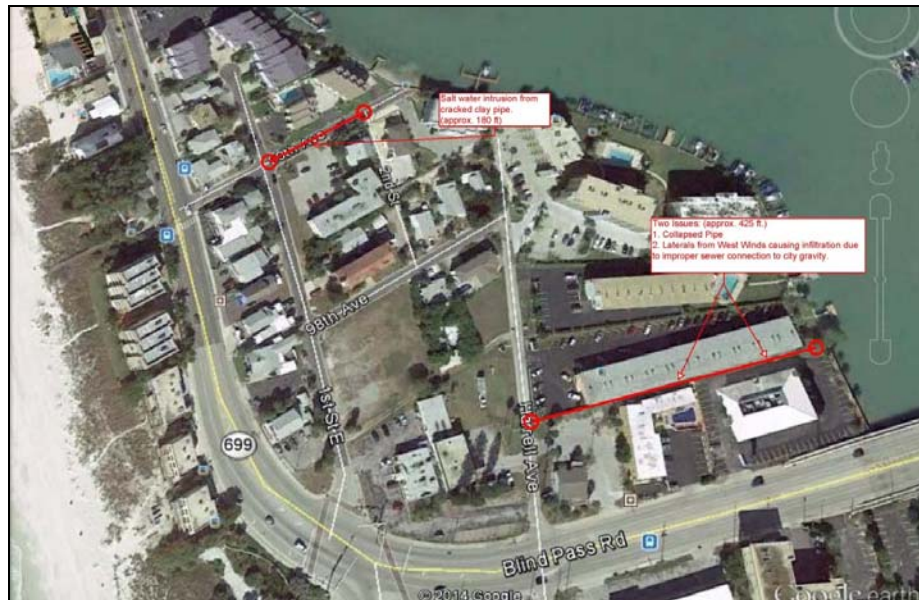
Figure 7. LS #3 Area with Extreme Infiltration

J.T.V. was contracted by the City of Treasure Island to rehabilitate the 8-inch diameter by 436 linear feet of vitrified clay pipe (VCP) sanitary sewer line. Within the scope of services was heavy cleaning to remove mineral deposits, removal of protruding service connections, pipe joint air test and seal, CIPP lining of the sanitary sewer main, nine lateral reinstatements, and lateral grouting.

Heavy mineral deposits were accumulated at each of the leaking joints and fractures. **J.T.V.** utilized robotic cutters to mill the mineral deposits from the VCP to minimize any additional damage to the pipe. Lining material was installed to an 8-inch diameter and 7.5 mm finish due to the shallow elevation of the pipe and overall longevity of the final product. Lateral grouting also required a higher than normal quantity of grout due to the existing voids from years of infiltration. Manhole 56 was an outside drop manhole, and it was determined that the last joint of the drop was severely separated allowing approximately 30 gallons per minute of groundwater to infiltrate into the system. **J.T.V.** plugged the bottom of the drop, pumped AV-100 into the drop, and sealed the section of pipe. The CIPP liner was extended into the manhole and a PVC inside drop was constructed to replace the defective drop. The finished product achieved a 91% reduction in chlorides and a 30% reduction in flow.
